NASA TN D-5524

EXPERIMENTAL INVESTIGATION OF ALUMINIDE-COATED Ta-10W FOR HEAT-SHIELD APPLICATIONS

by Gregory R. Wichorek and Bland A. Stein

Langley Research Center

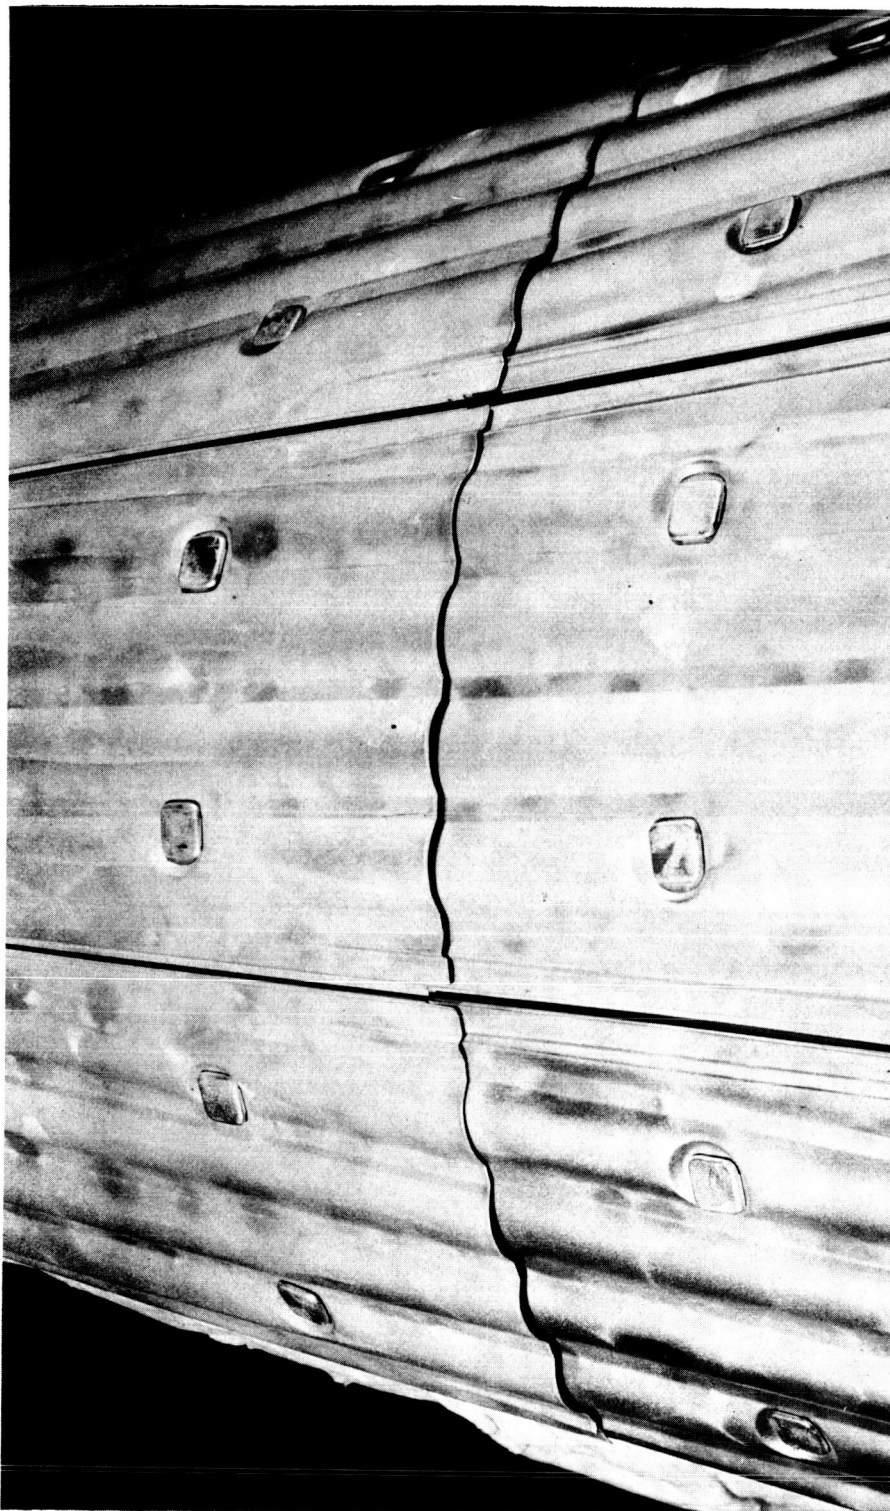
(a) Overall view.

Figure 7.- Curved shields, with Sn-27Al-5.5Mo coating, assembled on conical structure.

(b) Closeup view of mating edges.

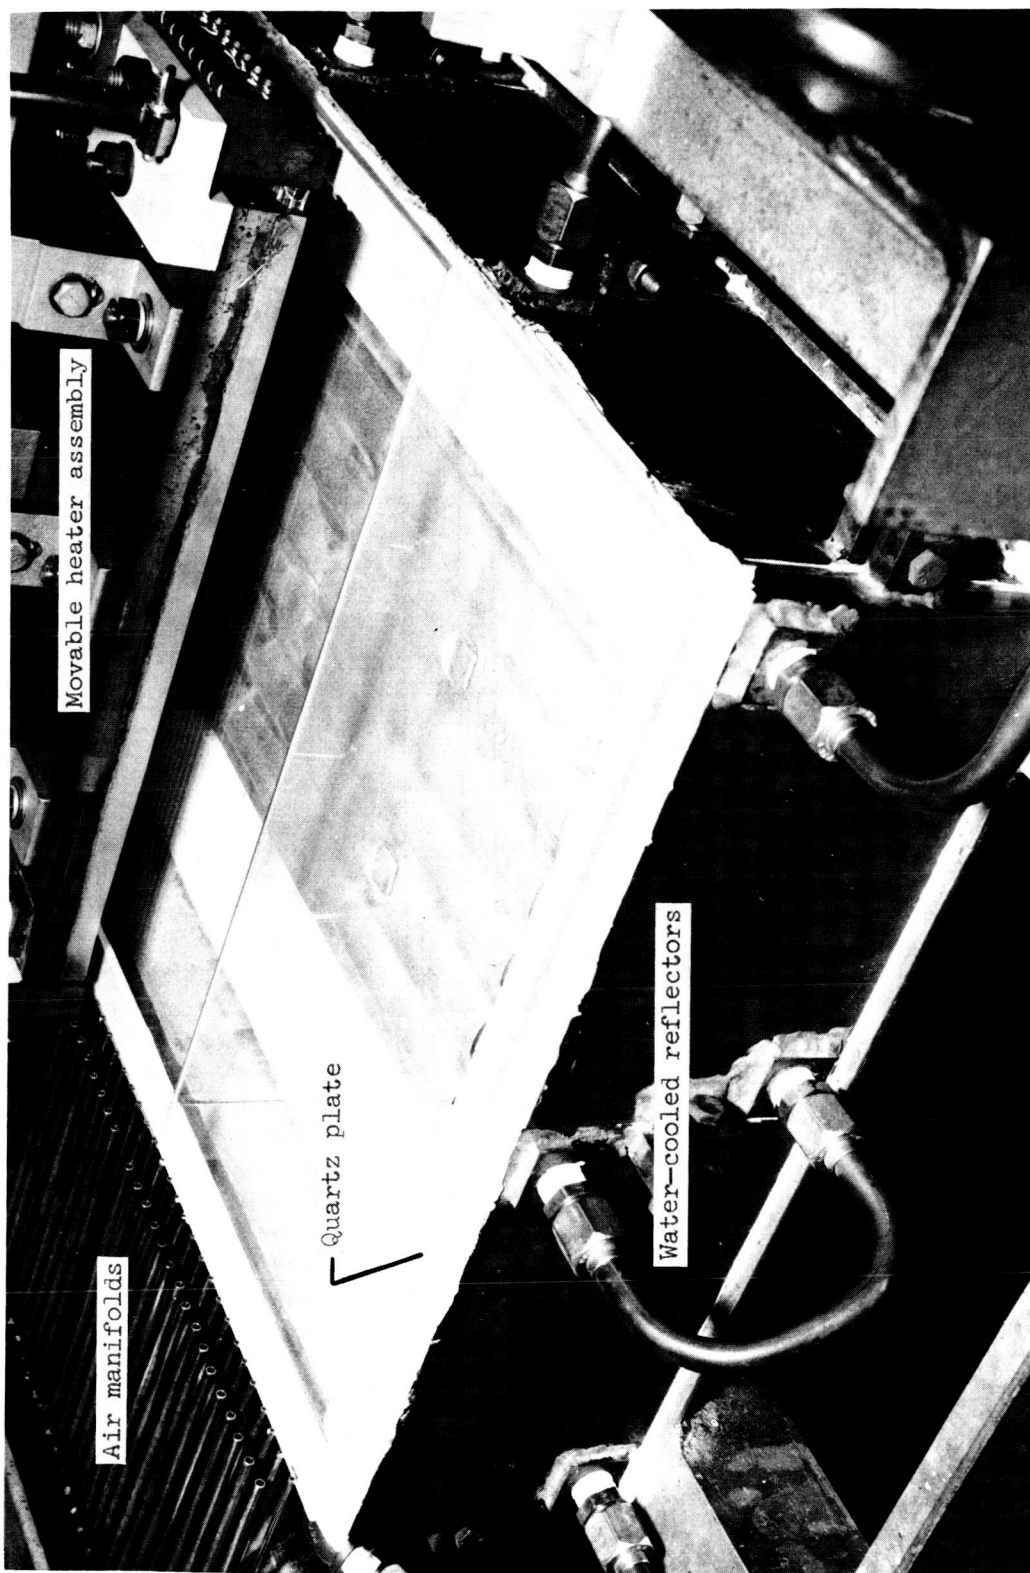
Figure 10.- Radiant-heating test setup with movable heater assembly in half-closed position.

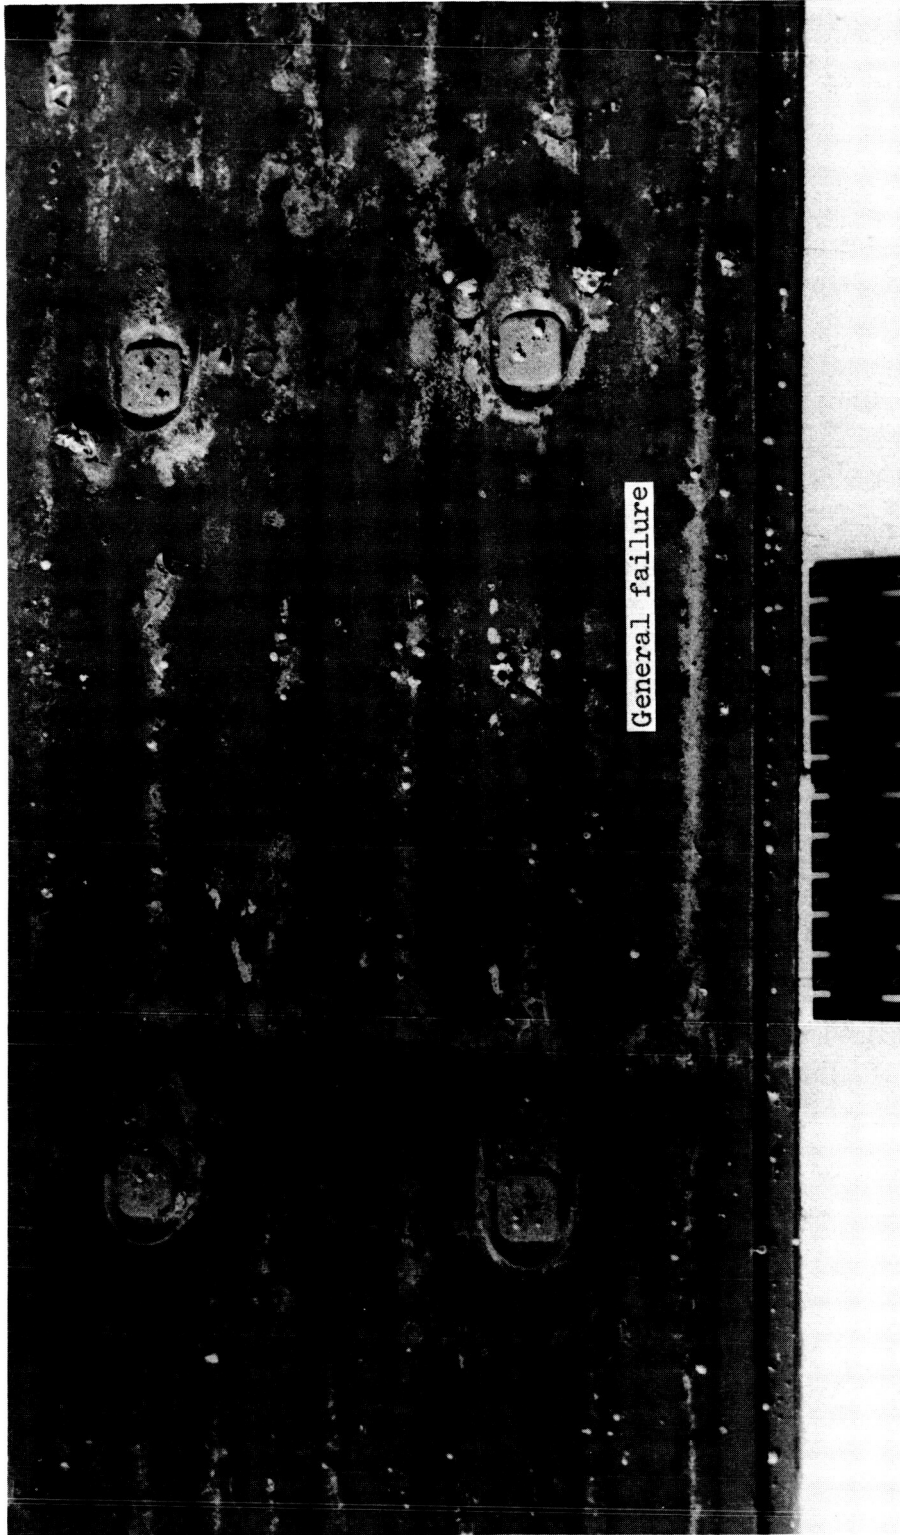
(a) After 4 cycles showing problem failures only.

Figure 25.- Coating failures on spotwelded tantalum-alloy shield 3 with Sn-27.5Al-6.9Mo coating after cyclic exposures to 2600° F (1700 K).

(b) After 11 cycles showing general and problem failures.

The 6.9Mo aluminide-coated shields (shields 3 and 5) experienced problem failures at approximately the same time as shield 2. (See table IV.) The problem areas in these shields were at the weld faying surfaces for shield 3 (fig. 25(a)) and at the rivet heads for shield 5 (fig. 26). For these 6.9Mo aluminide-coated shields, failure was attributed, at least in part, to the increased viscosity of this coating over the 5.5Mo aluminide coating. An increase in coating viscosity could reduce the mobility of the Sn-Al phase and thereby decrease the self-healing characteristics and coating life. The transport rate of aluminum in the liquid Sn-Al phase is of importance in areas of welds and rivets where coating

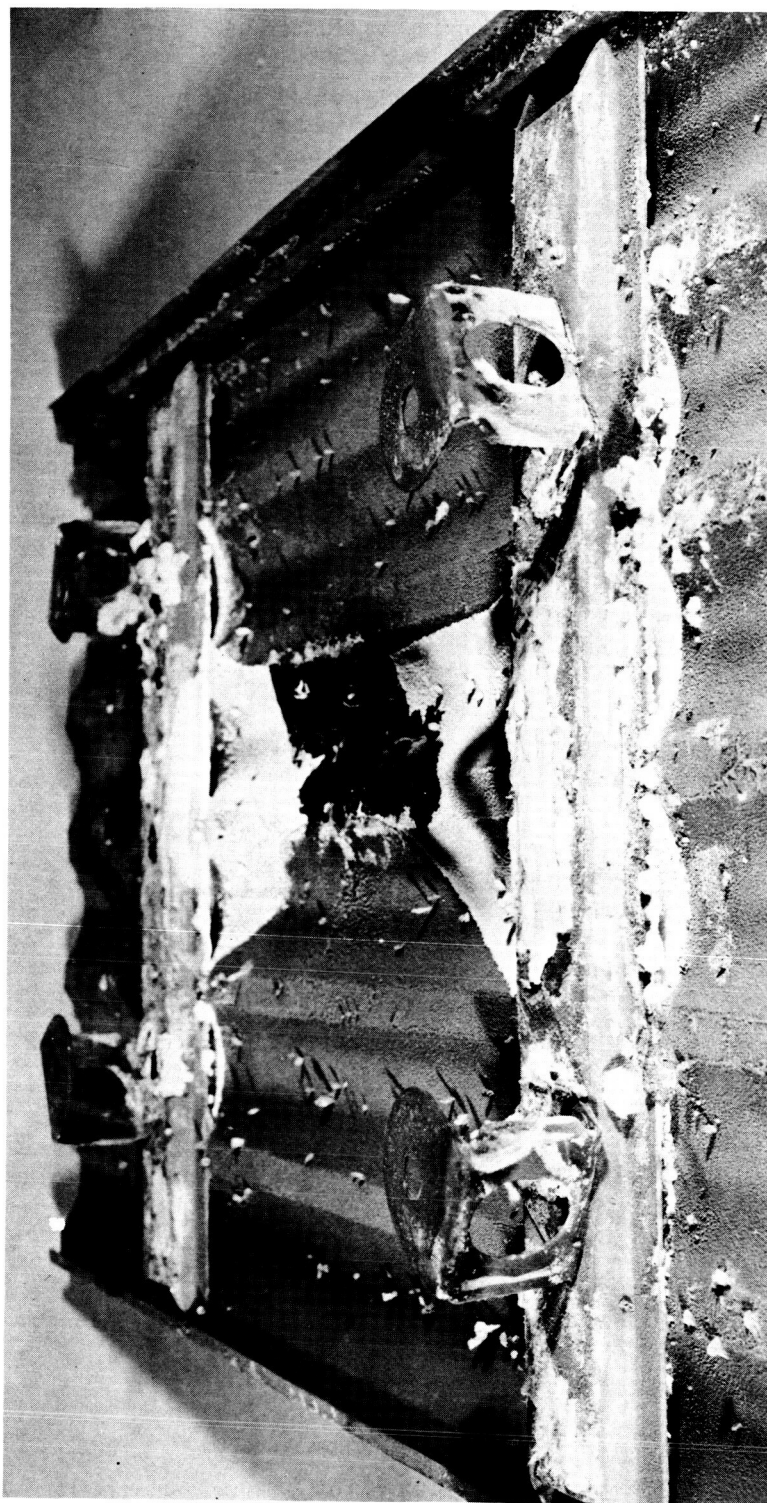
(a) Outer surface appearance.

Figure 27.- Failures on Sn-27.5Al-6.9Mo coated Ta-10W shield after 3 cycles at 2900° F (1865 K).

(b) Inner surface with white deposit of $\alpha\text{Al}_2\text{O}_3$.

(c) Deposit of $\alpha\text{-Al}_2\text{O}_3$ under hat sections.

This heat-shield panel is shown in figure 27 after 3 cycles to 2900° F (1865 K). The dark area shown in figure 27(a) is yellow and black and, under close examination, has a fused appearance. In a few places along the edge of the hole, black crystals could be seen. No attempt was made to determine the constituents in this area. However, similar black crystals which had formed at a failure site on a Sn-27.5Al-6.9Mo heat shield tested at 2600° F (1700 K) were identified as SnO₂ (cassiterite) by using X-ray diffraction techniques. Disassembly of this heat-shield panel after coating failure revealed a white, powdery deposit on the inner surface of the corrugated shield. (See fig. 27(b).) The deposit covered the area under the hat sections to the flats in the corrugated skin just beyond the access holes. (See fig. 27(c).) This white powder was identified as α Al₂O₃ (corundum) by using X-ray diffraction techniques.
